Approved For Release 2002/10/31 : CIA-RDP89B00980R000300030010-8		ENGINEERING STUDY <input checked="" type="checkbox"/>	LAC - 8	DPD-2065-5 COPY 3 OF 4						
Lockheed Aircraft Corp.		CHANGE PROPOSAL <input checked="" type="checkbox"/>								
DATE 3-19-59		AFFECTS: WSPO <input checked="" type="checkbox"/>		PROJECT <input checked="" type="checkbox"/>						
NAME OF MAJOR COMPONENT Airplane		PART OR LOWEST SUBASSEMBLY Drag Chute Hook Assy.		PART NO. & MODEL OR TYPE F 180-121						
TITLE OF PROPOSAL : Rework - Drag Chute Hook Mech.										
<p>NATURE OF PROPOSAL: This proposal includes Mod. and overhauling the Drag Chute F-180-121 Hook Assembly, plus addition of a warning flag on the hook. The mech. is mod. by eliminating the F-180-164 Cam and 726233 Spring. The F-180-126 Catch and F-529-2 Arm are replaced by improved parts F-706-2 Catch and F-706-3 Cross Arm. New F-180-112 Rockers and Bearings will be supplied to replace worn rockers. F-180-137 Pin will be replaced by a bolt and nut. The F-180-119 Lever Assy. will be replaced by new modified assy's. Travel stops for the lever are added. A drill template will be supplied for the forward stop location. Replacement F-475-2 Springs will b

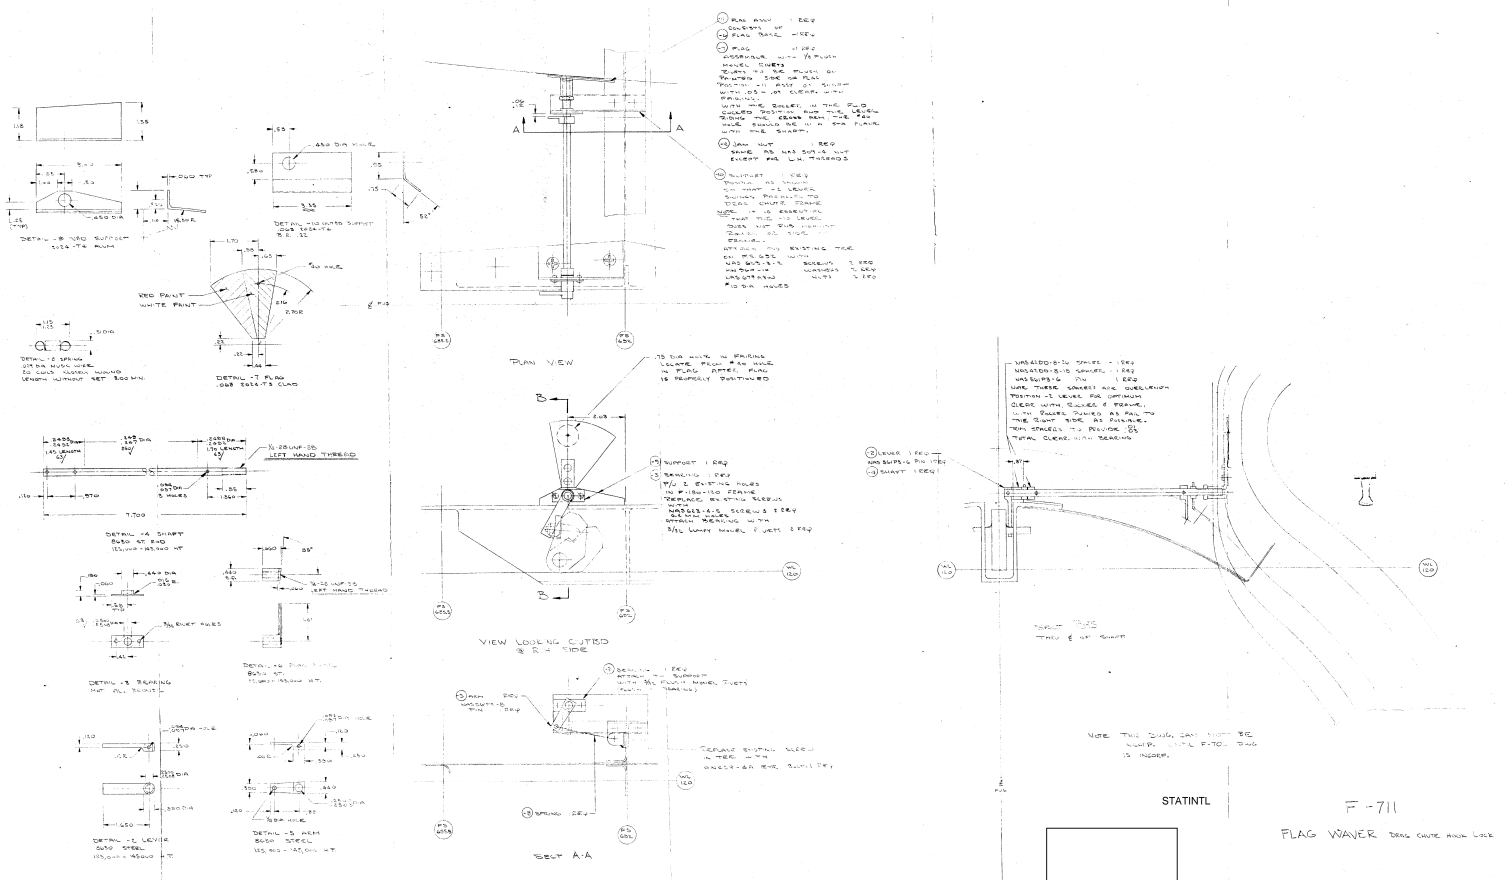
The Hook Assy. mod. required the F-180-122 Catch be spring loaded closed. F-706-4 Clip, F-706-9 Spring, F-706-5 Socket Bolt, NAS322-13-0063 Cable Assy., MLB Aluminum Pulley are required for this mod.

The warning flag is shown on F-711 drawing, consists of a spring loaded shaft with a lever on one end riding on the rocker cross arm and a red and white colored flag on the other end inside the tail fairing.

This flag is visible thru a .75 dia. hole in the fairing. The color showing indicates the rigged condition of the hook. White indicates hook unlocked and "OK". Red indicates the hook locked and chute un-jettisonable. This is to be used on a pre-flight walkaround inspection.

Preliminary copies of drawings F-706 and F-711 are attached.
